CARDIVNSWC-TR-62-00-05 June 2000

Survivability, Structures, and Materials Directorate Technical Report

LABORATORY EVALUATION OF LABEL PLATE
MATERIALS AND ATTACHMENT METHODS CONSIDERED
FOR USE ON LPD-17

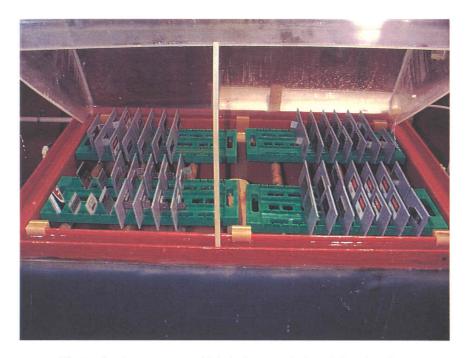
Figure 1: Arrangement of label plate panels in salt fog chamber.

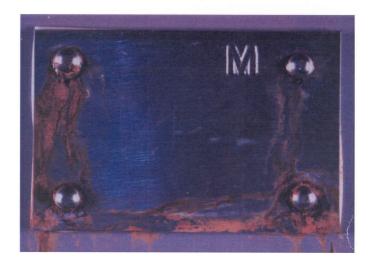
**Figure 2:** Monel 400<sup>TM</sup> label plate with 3M<sup>TM</sup> model 4946 double-sided tape, no sealant in fastener holes. Bulkhead panel has corroded at fastener attachment points resulting in running rust.

Fastening of a label plate to the bulkhead with mechanical fasteners, adhesive tape or adhesives/sealants in all cases appeared to be a viable option. The results indicate, that if a mechanical fastener is used, the fastener holes must be filled with sealant prior to the drive rivet being hammered in place. Trapped water will eventually corrode the bare steel surface in the drive rivet hole around the rivet causing running rust from the fastener attachment point if a sealant is not used as shown in figure 2.

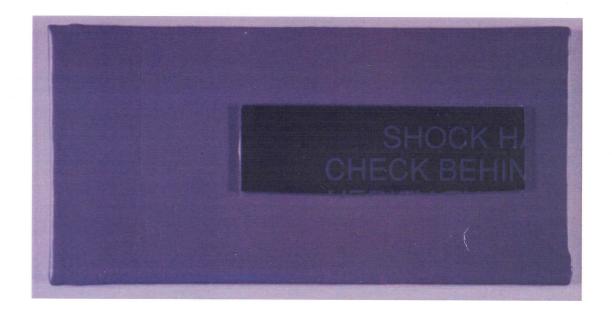
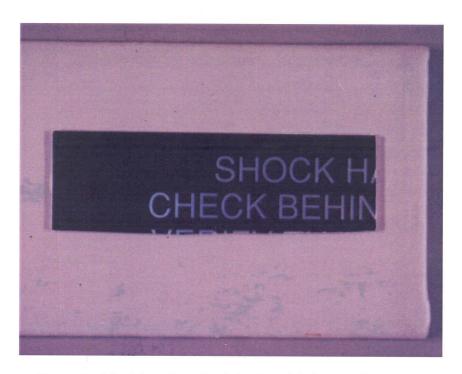
**Figure 10:** Metalphoto® anodized aluminum label plates with 3M<sup>TM</sup> Series 1160 Premium Protective Overlay Film before (upper) and after (below) environmental exposure.

All varieties of the Metalphoto® label plates were in excellent condition following all phases of exposure. There was no evidence of surface discoloration, pitting or fading. Figures 9, 10 and 11 pertain. The 3M<sup>TM</sup> Premium Protective Overlay Film, Series 1160 and the Hitef2<sup>TM</sup> Teflon paint shedding overlaminates were in excellent condition. There was no evidence of wrinkling or delamination from the environmental exposure. However, scratching of these surfaces with a fingernail did cause the overlaminates to mark and wrinkle suggesting that they are not very abrasion resistant.

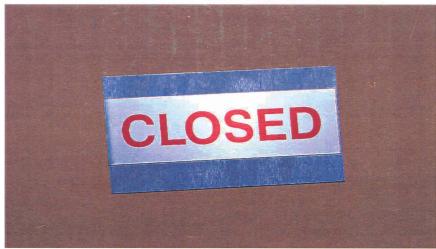
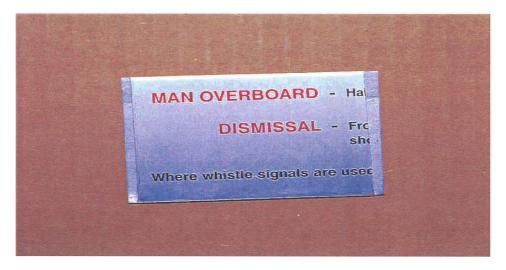
**Figure 11:** Colored Metalphoto® label plates following environmental exposure. There is no fading or loss of clarity of the printing on these labels.
